CR LAURENCE CO, INC.

ACOUSTICAL PERFORMANCE TEST REPORT

ASTM E90 SOUND TRANSMISSION LOSS TESTING ON A D900 TD-42" X 96" DOOR SYSTEM

H9895.01-303-11 R0

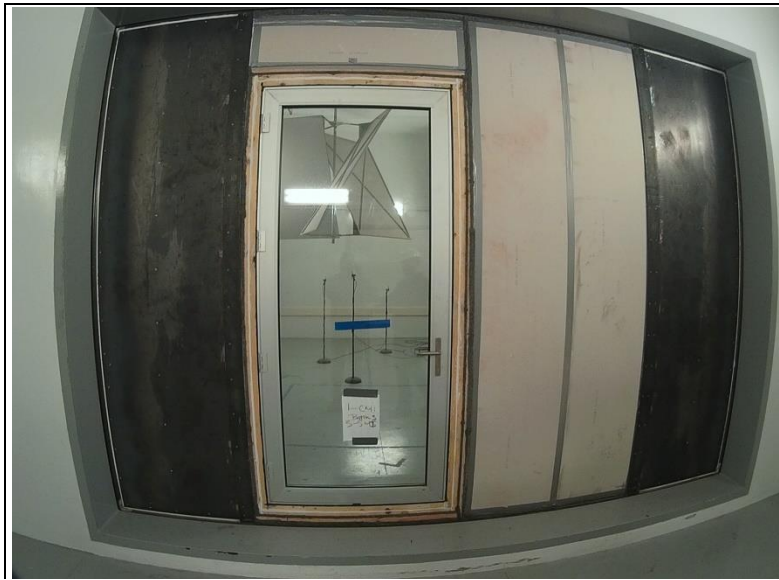
Photo No. 1
Source Room View of Test Specimen

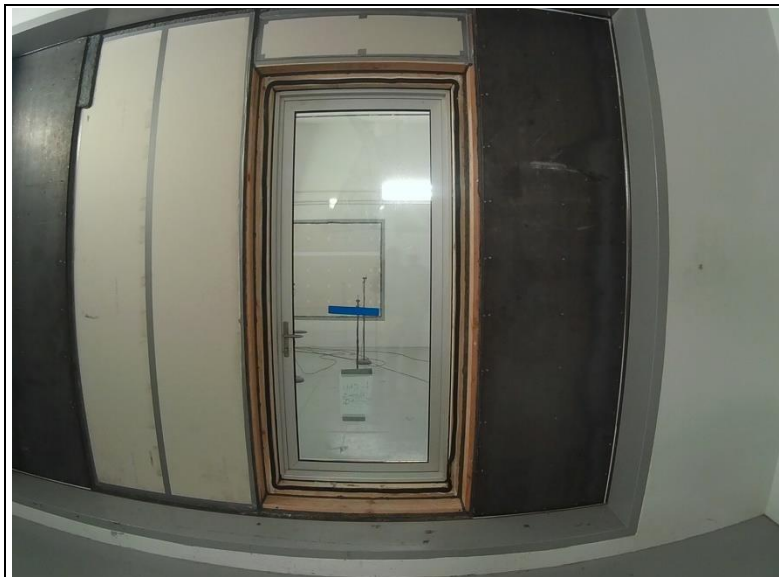
Photo No. 2
Receive room
